COMPLETED WORKS

CURRENT WORKS

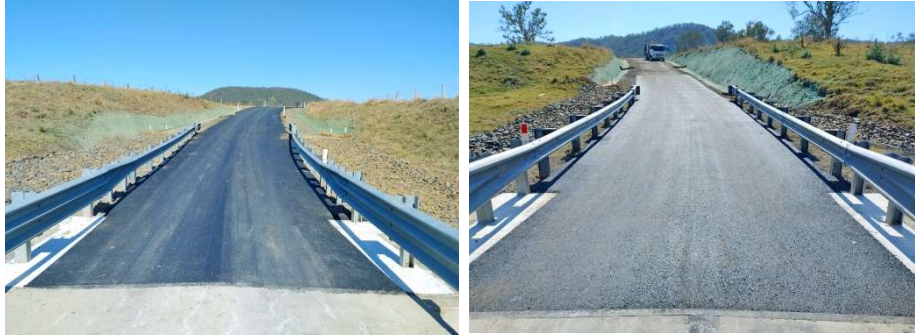
Bungabbee Road Completed Bridge Approaches

Recently the Bungabbee Road bridge approaches works were completed to repair damages from the 2022 natural disaster. The works involved re-construction of the damaged approaches and re-instatement of guard rails, drainage, and scour protection around abutments.

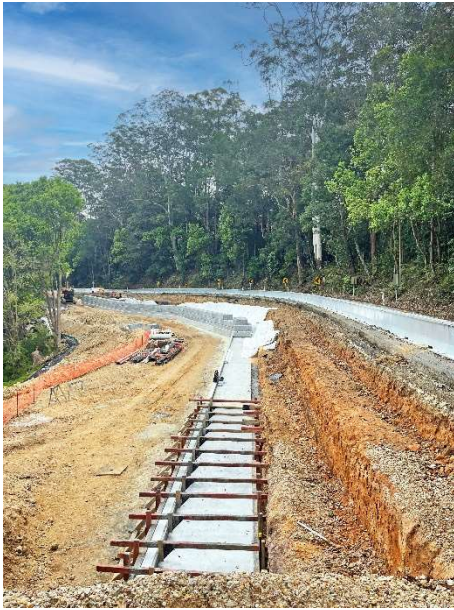
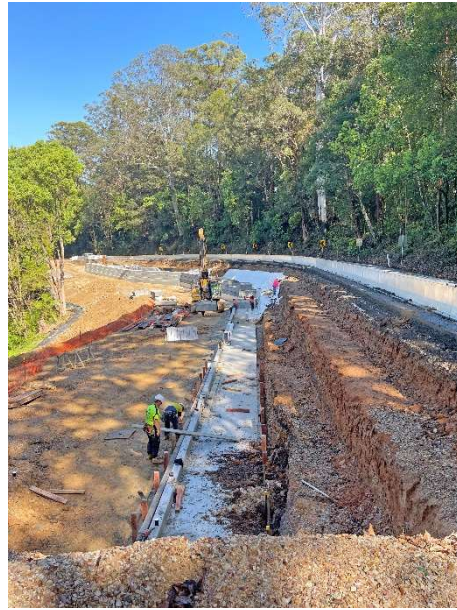
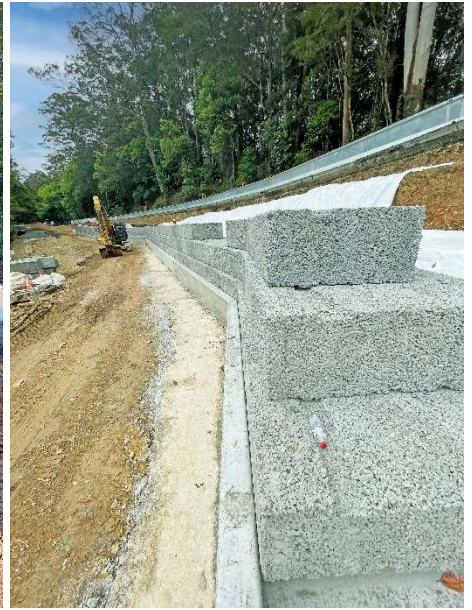
Progress Photos for Site Km1

Works are continuing for the Nimbin Road landslips. Site Km1, located 1 Km from Nimbin has all the concrete works and piling complete with the installation of block wall in progress. This site is on schedule for the road to be fully open before Christmas. Site Km4, located 4 Km's from Nimbin is currently undergoing construction of gabion walls, these are used for scour protection, which prevents soil from being washed away and helps strengthen the road. The site also has piling in progress with approximately 30% completed.

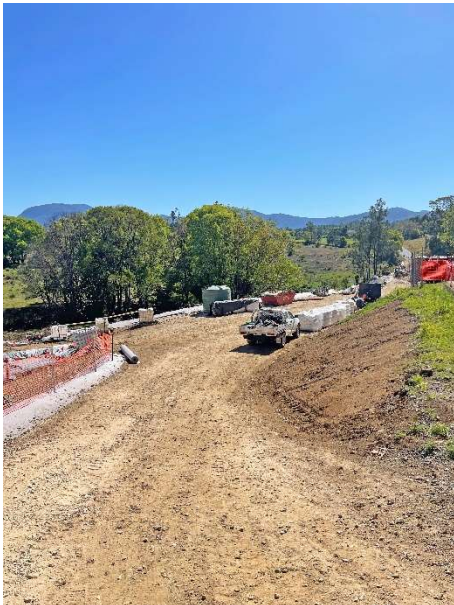
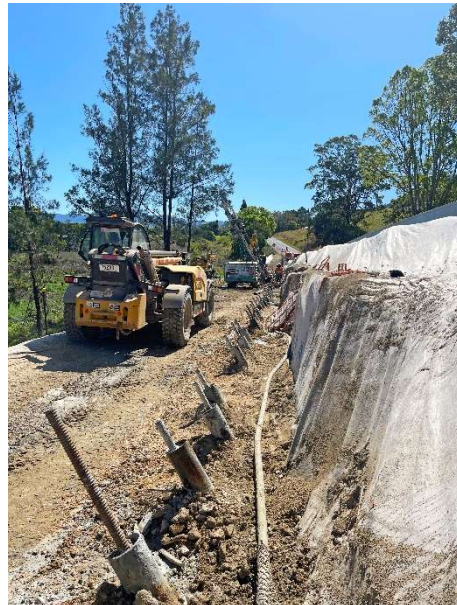
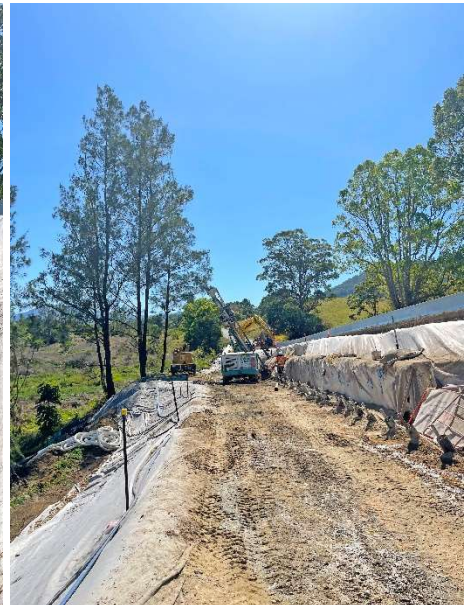
Progress Photos for Site Km4

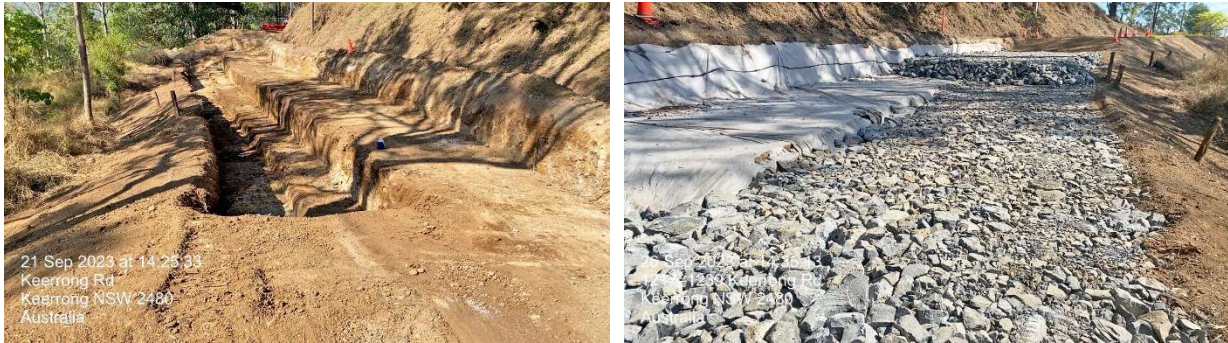
Keerrong Road before and after excavation and drainage rock works

Works have commenced on Keerrong Road for excavation of slipped material and reconstruction of the road embankment. The works are scheduled for approximately 3 weeks, subject to weather, contractor, and material availability. A full road closure will be required around the works zone throughout the works period. A detour is available via Pinchin Road, motorists will be notified ahead of the closure via roadside signage, updated through www.livetraffic.com. Residents will have access to their properties via Pinchin Road and The Channon Road but will be unable to drive through the landslip work zone. Please adhere to all road closed signs and directions from any traffic controllers.

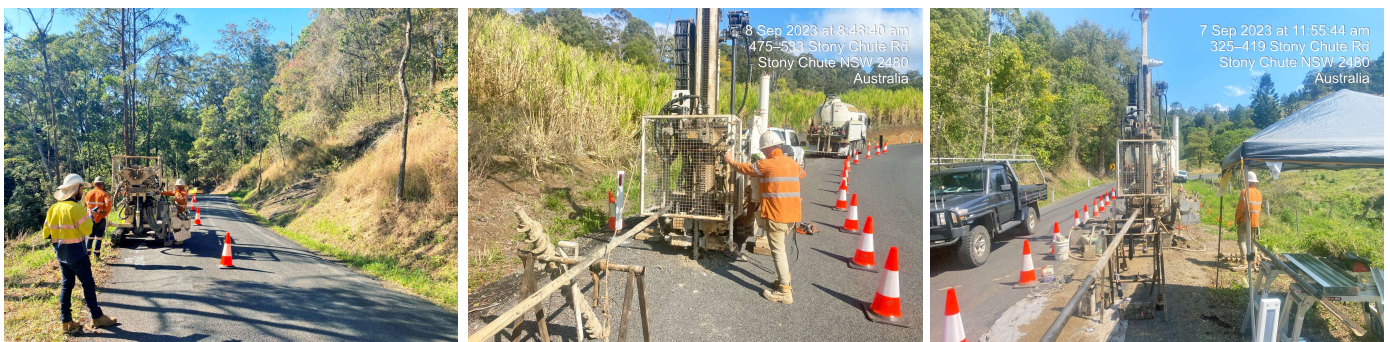
Geotechnical Investigations on Stony Chute Road

Geotechnical drilling is a type of drilling that is performed as part of the construction process to assist with better understanding a site. Investigations involve collecting rock and soil samples to obtain data regarding surface and subsurface examination. These samples provide valuable insights into the physical properties of the site, enabling engineers to design and construct remediation works to deliver roads that are safer and more durable.

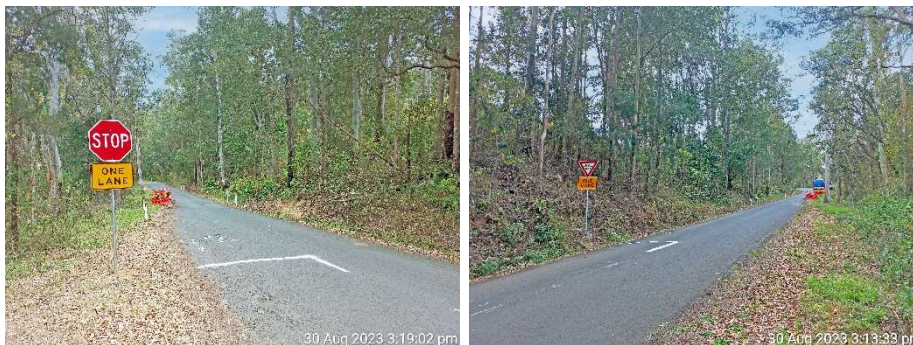
Cawongla Road Traffic Management Changes

Significant changes to the traffic control measures at the Cawongla Road Landslide site, near Martin Road, were recently implemented. It was identified that the site was deemed unsafe due to technical issues with the traffic lights, including repeated battery charge depletion, and concerns about safety. Therefore, the traffic lights previously regulating traffic flow have been replaced with a “Give Way” sign and a “Stop” sign. This decision was prompted by multiple incidents of road users running the red lights, posing a serious safety hazard. The new signage system aims to simplify traffic management while mitigating potential hazards. All signage has been installed as per the amended traffic guidance scheme, and a comprehensive risk assessment was conducted before implementing these changes to ensure the safety of all individuals travelling through the site.
