Results of Noise Monitoring

**Blakebrook Quarry
550 Nimbin Road
Blakebrook NSW 2480**

Prepared for
**Northern Rivers Quarry & Asphalt
550 Nimbin Road
Blakebrook NSW 2480**

Prepared by
Garry Hall
December 17th 2019

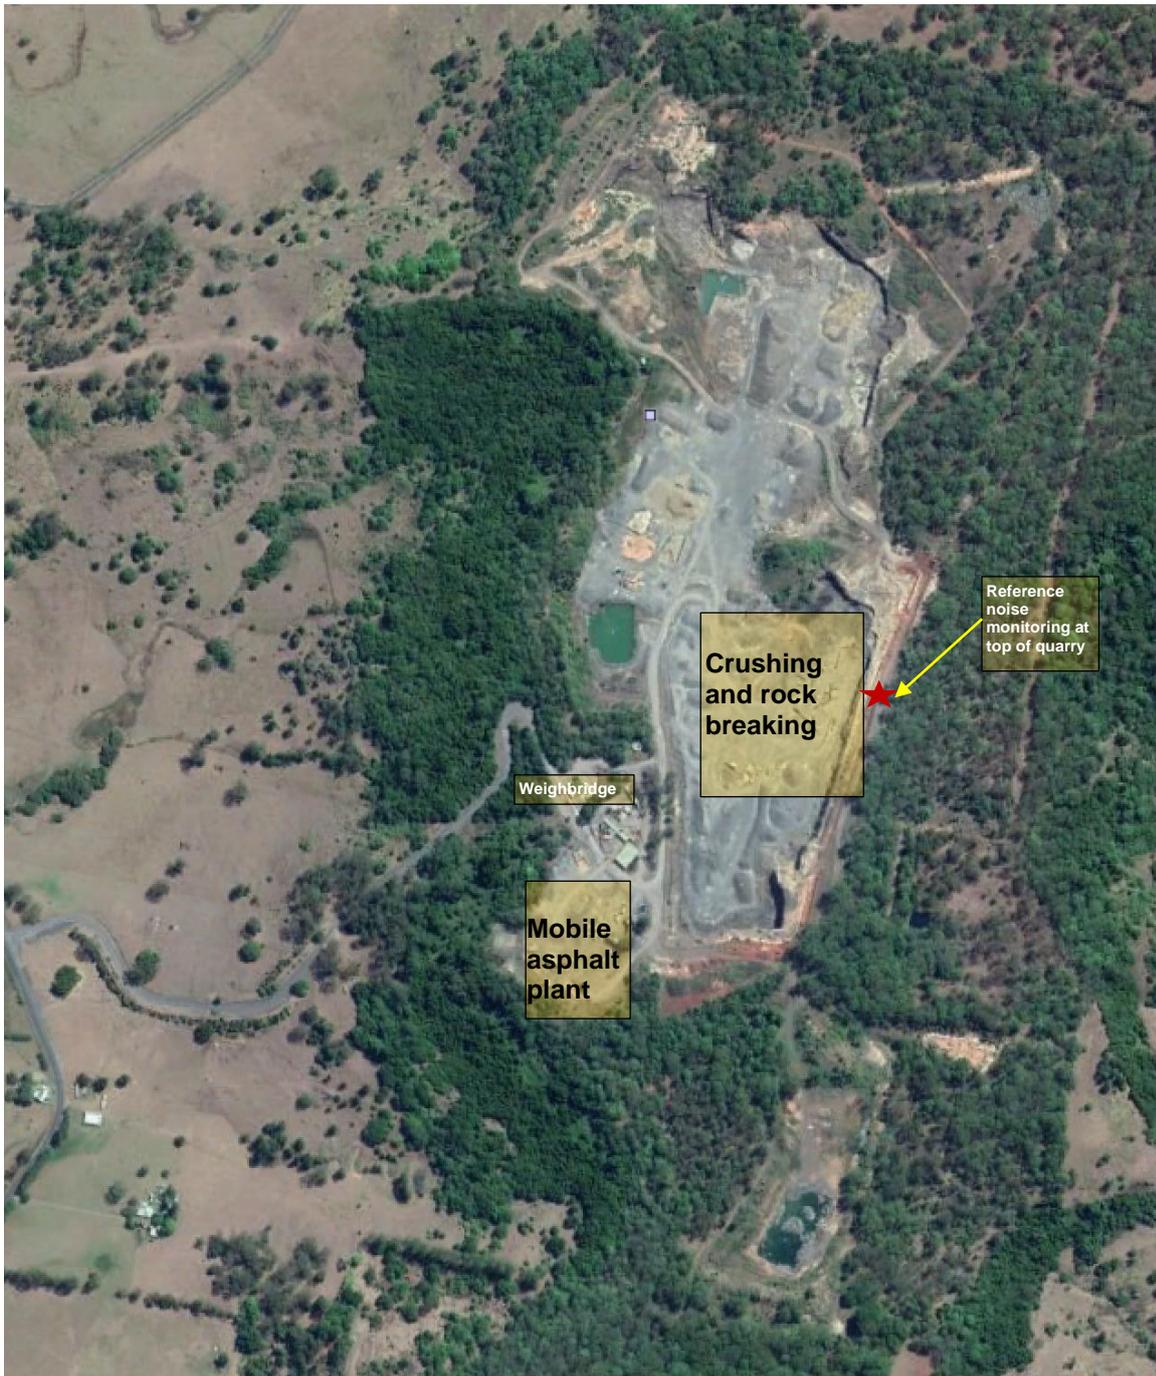
Appendix D
Quarry Operations 6th Nov & 10th Dec 2019

Note : Aerial photo not of operations on 6th of Nov or 10th Dec 2019

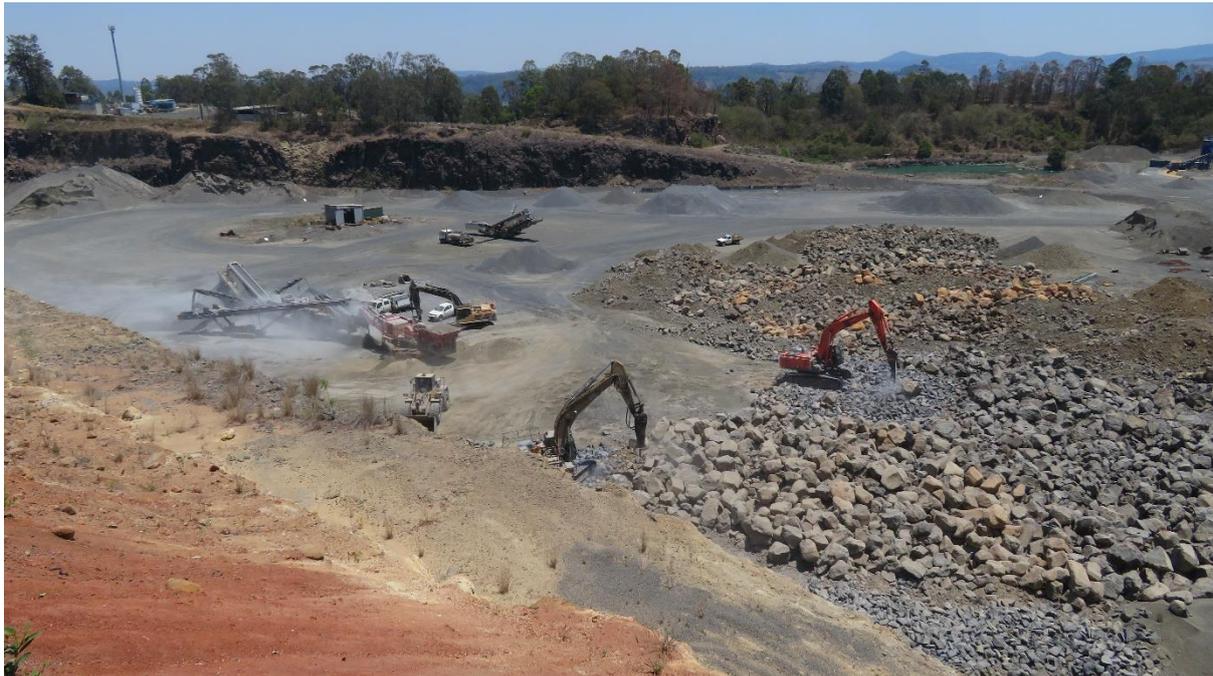
Quarry Pit Floor Operations 6th November 2019

Equipment in use during noise monitoring

- 1 jaw crusher
- 1 screen deck
- 1 cone crusher
- 2 excavators
- 2 rock breakers
- 1 powered stockpiler
- 2 front end loaders
- 1 water truck
- various haul trucks
- various service vehicles

The mobile asphalt plant was also operating
