Roads and Bridges Flood Restoration Works Update – January 2023

COMPLETED WORKS

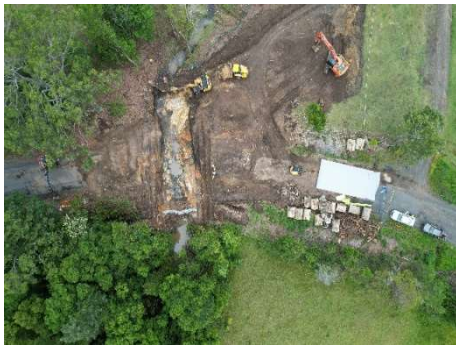
Culvert replacement works

Excitingly, the Cawongla Road pipes’ replacement project was ahead of schedule and the road opened at the end of January before school started. We would like to thank all the residents of Larnook and the surrounding region for their patience and cooperation during these repairs. The works consisted of replacing two culverts that suffered significant damage during the 2022 floods. Further details can be found on the latest Cawongla Road update on the following link:

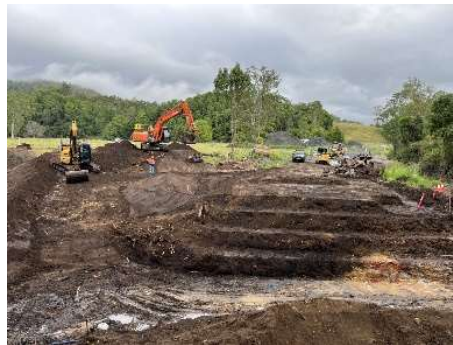
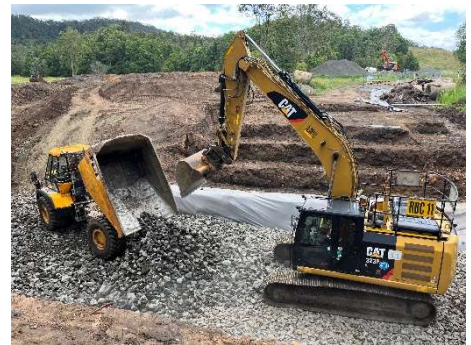
Excavation Works

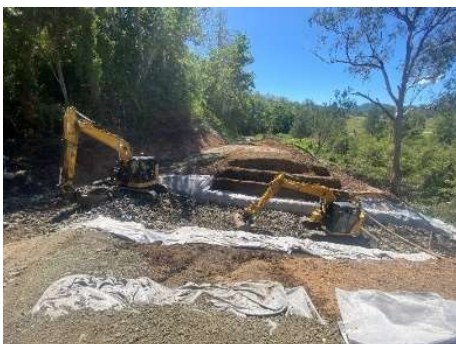
North Site – Twin Cell 1350mm Pipes

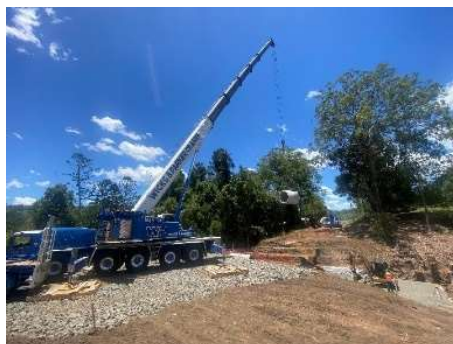
South Site – Twin Cell 1800mm Pipes

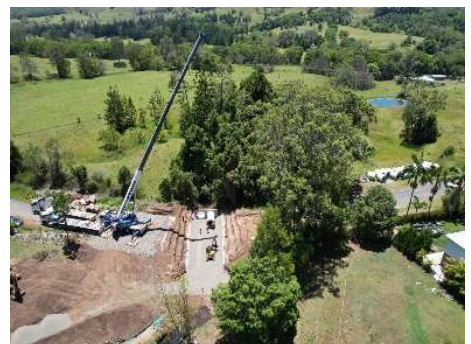
Aerial view of pipe installation

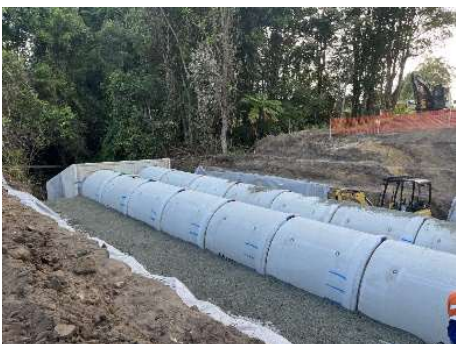
Pipe Installation

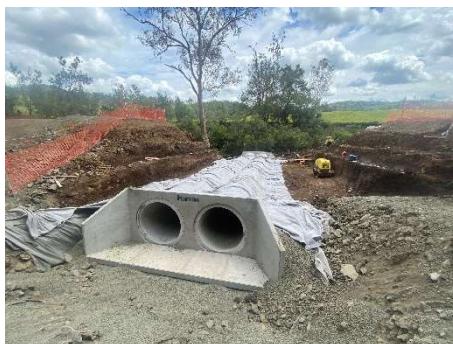
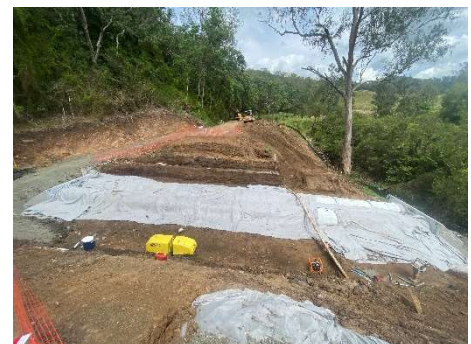
1350mm twin cell pipes and headwalls

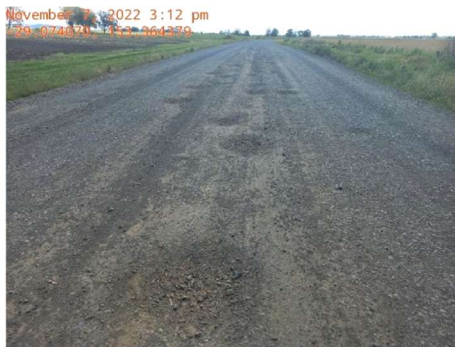
Sheehan Road (Before Works)

Works have been completed on Sheehan Road to address issues caused from the February and March 2022 floods. This has involved overlay and drainage works to repair flood damages.

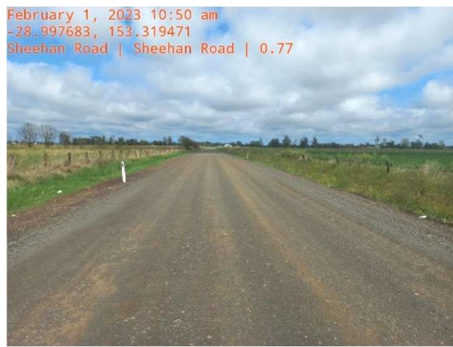
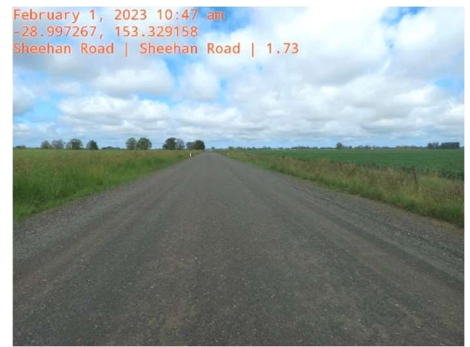
Sheehan Road (After Works)

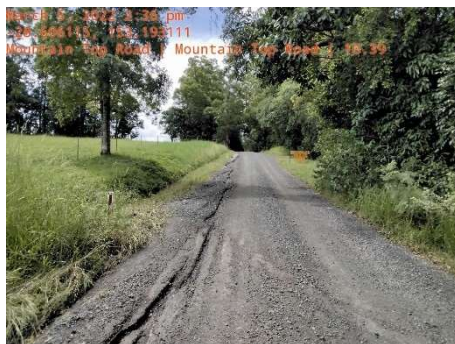
Mountain Top Road (Before Works)

Overlay works have been completed on Mountain Top Road, Standing Street, Nimbin Street and Wallace Road, to address issues caused from the February and March 2022 floods.

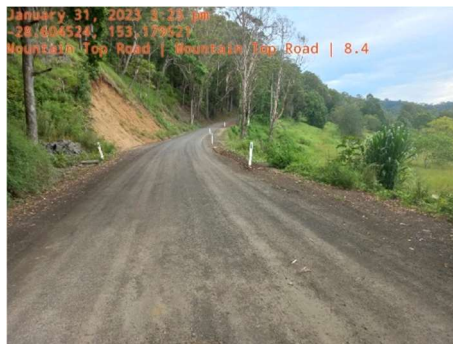
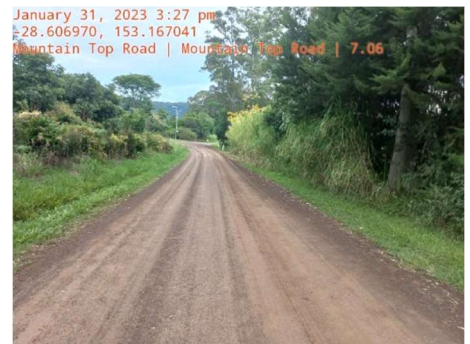
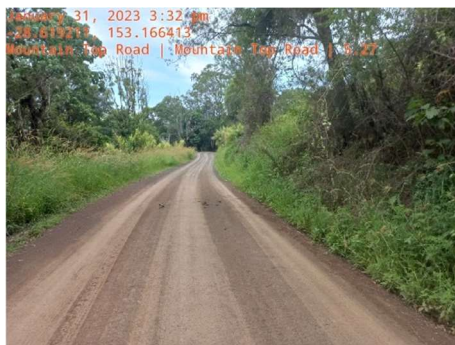
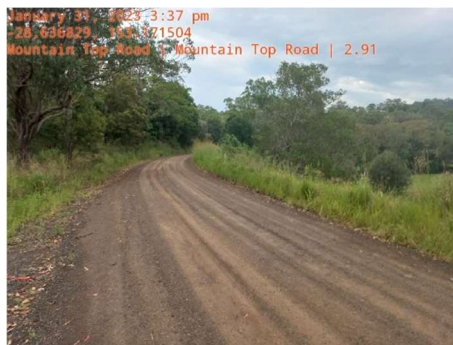
Mountain Top Road (After Works)

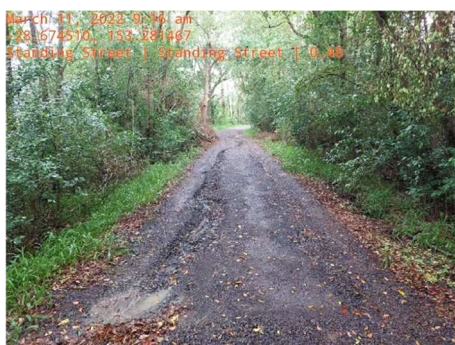
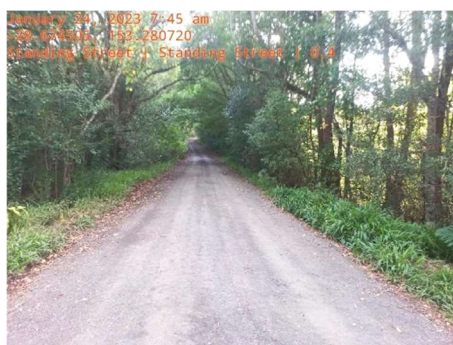
Standing Street (Before Works)

Standing Street (After Works)

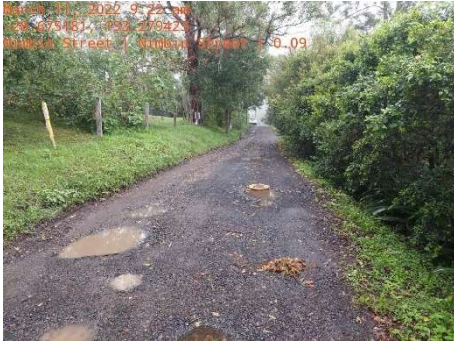
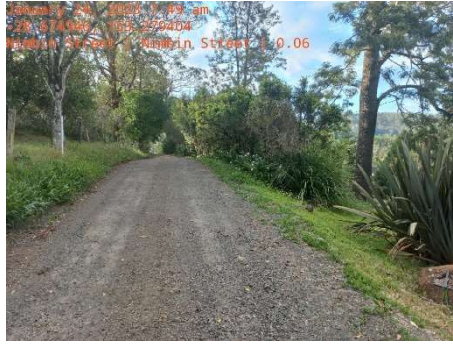
Nimbin Street (Before Works)

Nimbin Street (After Works)

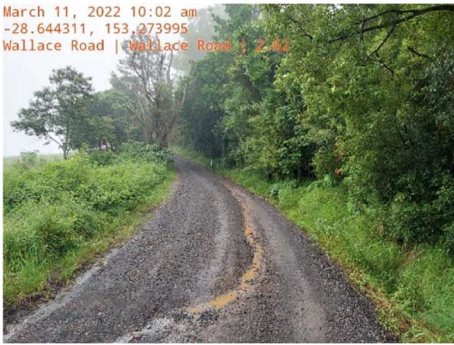
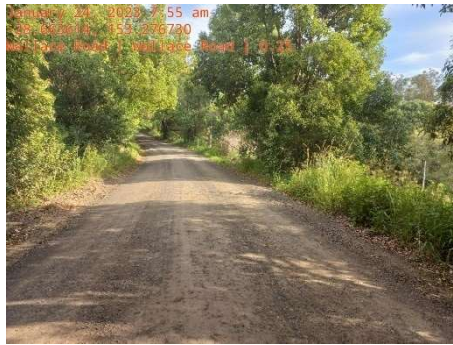
Wallace Road (Before Works)

Wallace Road (After Works)

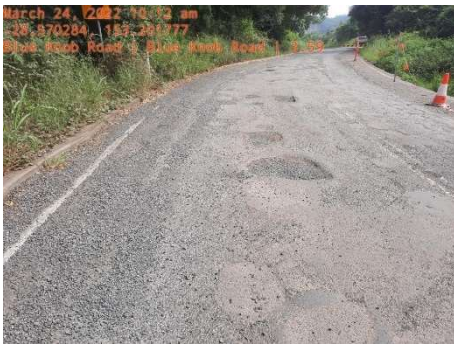
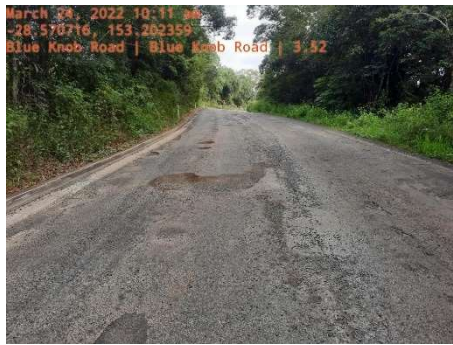
Blue Knob Road (Before Works)

Works are completed for Blue Knob Road, these included removing and replacing the existing material from the road surface, along with grading and rolling the road with a temporary seal over the new surface. A planned return to complete permanent works will be scheduled during 2023.

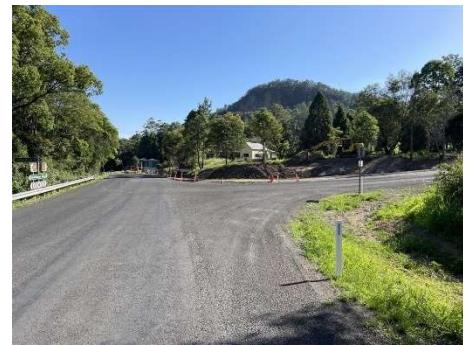
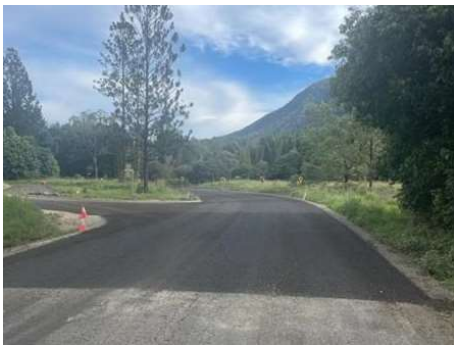
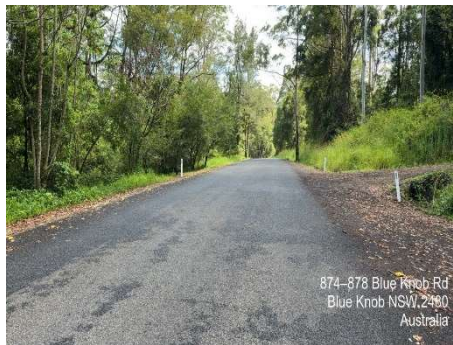
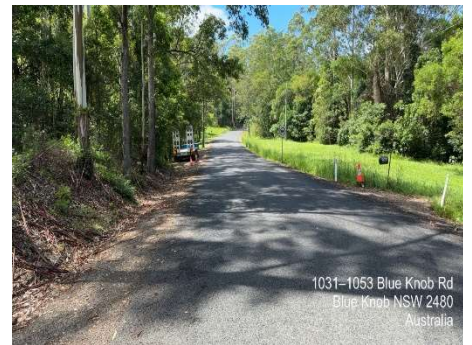
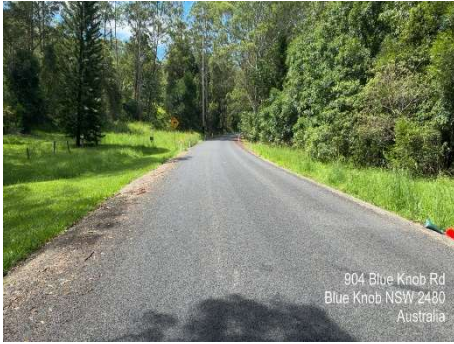
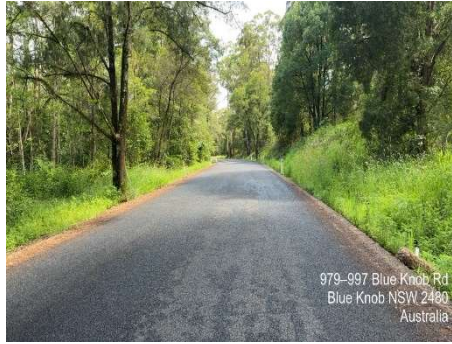
Blue Knob Road (After Works)

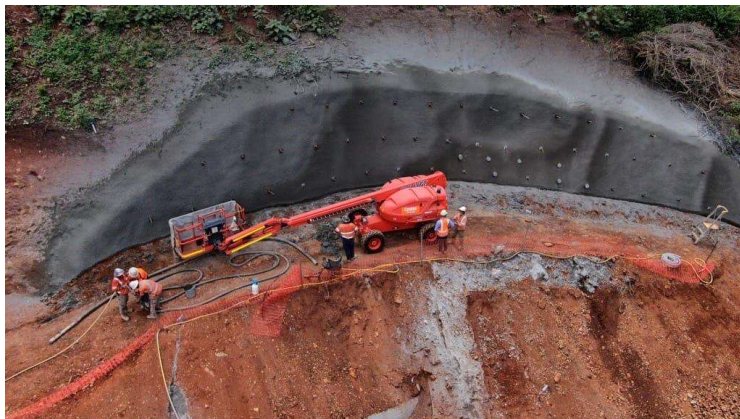
Tunable Creek Road Works Aerial View

The works crew remobilised to the site at the beginning of January, this stage of construction consists of excavating into the slope above the road and installing 49 soil nails and 100m² shotcrete. Additionally, crews are also reconstructing pavement through the slip zone and installing light traffic control and opening one lane. The works are expected to be complete in February with additional updates to be provided as the works commence on the upper slope. For further details please visit the Tuntable Creek Road update link below:

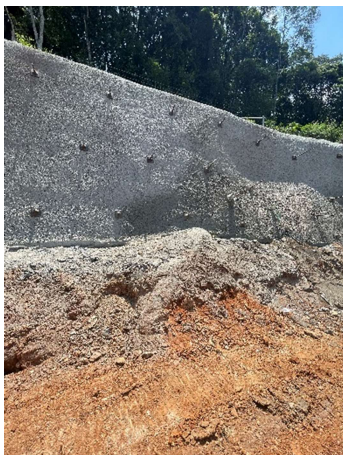
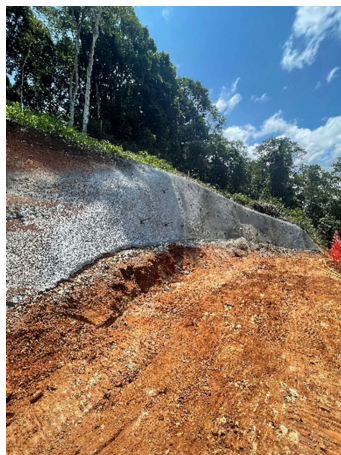
Tunable Creek Road Soil Nails

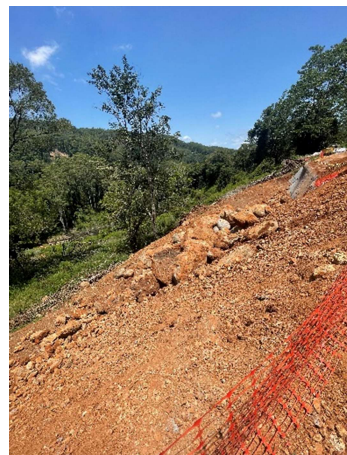
Tunable Creek Road Works
