COMPLETED WORKS

Cawongla Road

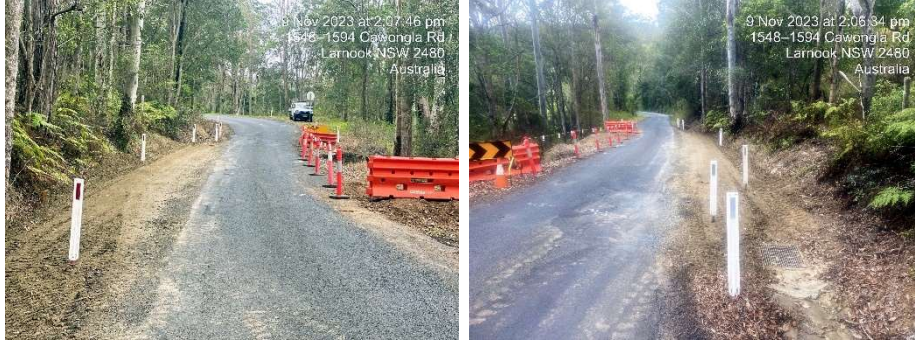
Cawongla Road – Completed Works

Recently work crews made the road wider on Cawongla Road around the landslip area. You can locate the exact region through viewing our IntraMaps and selecting 'Major Flood Recovery Works' these works are found at damage No. DM00666.

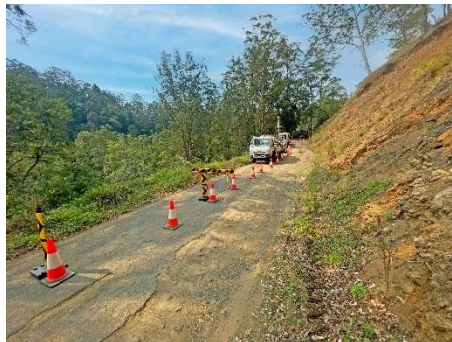
Geotech Drilling on Mountain Top Road

During the month our contractors closed Wallace Road and Oakey Creek Road to perform geotechnical investigations. This involved using a drilling rig to understand subsurface conditions. We would like to thank residents for your patience and resilience during this time.

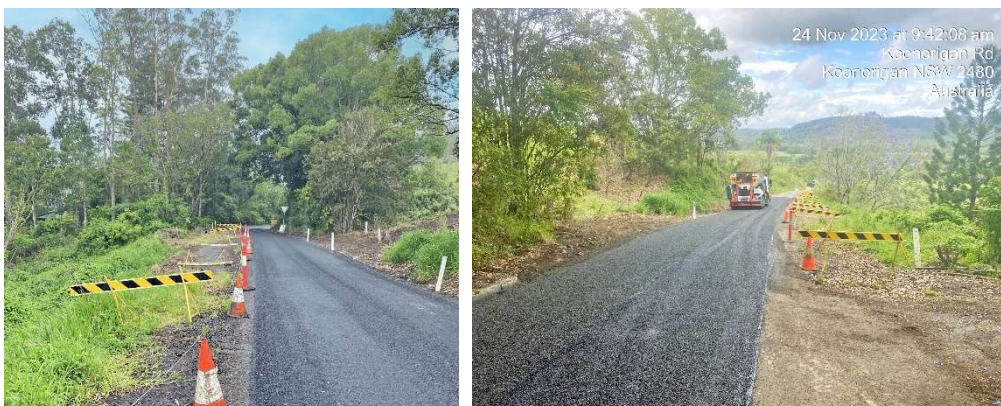
Koonorigan Road – Maintenance Works

Road maintenance works were recently completed for Koonorigan Road with a new seal laid to improve the road condition and impact on residents. Geotechnical investigations were also performed during this period, and we would like to thank the community for their continuing patience.

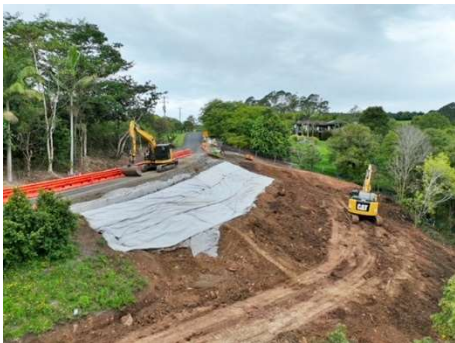
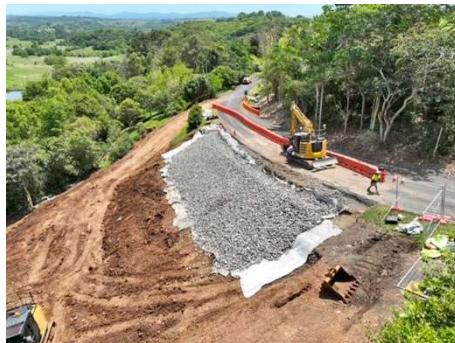
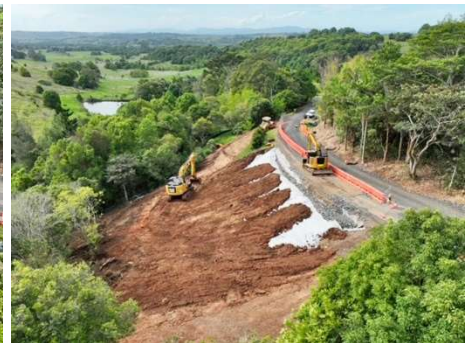
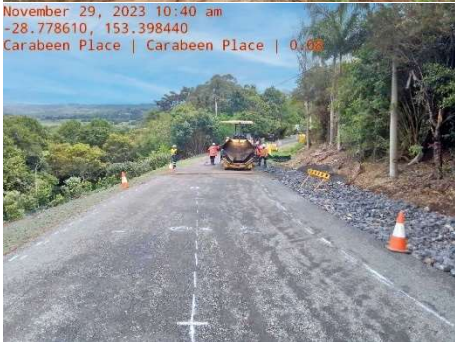
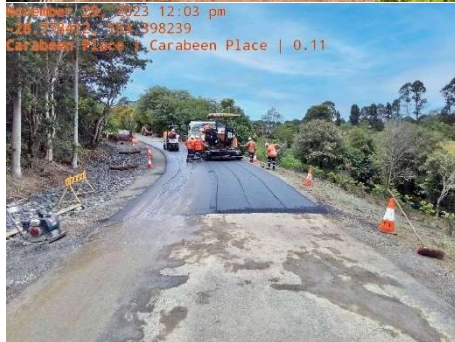
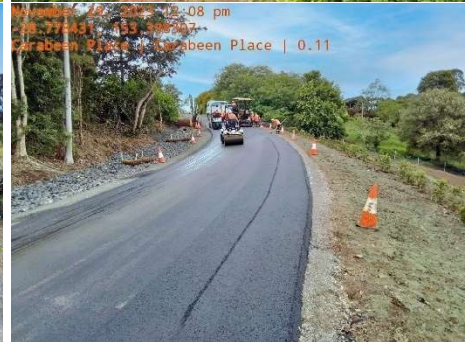
Carabeen Road Progress Update

Carabeen Place is progressing on schedule with asphalt now completed at the site. Work crews are finalising works to prepare for a reopening of the site. Thank you to the residents for your patience during the works period.

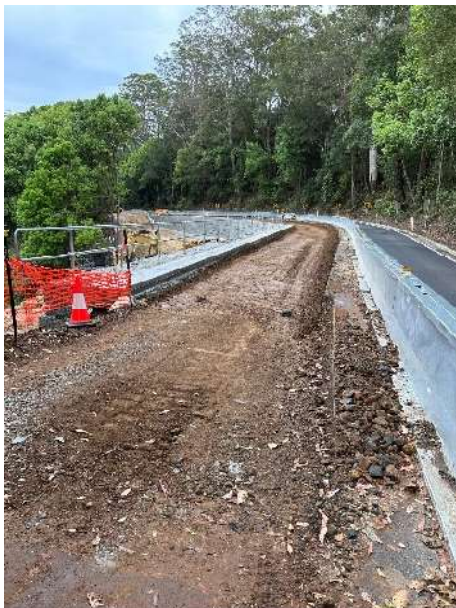
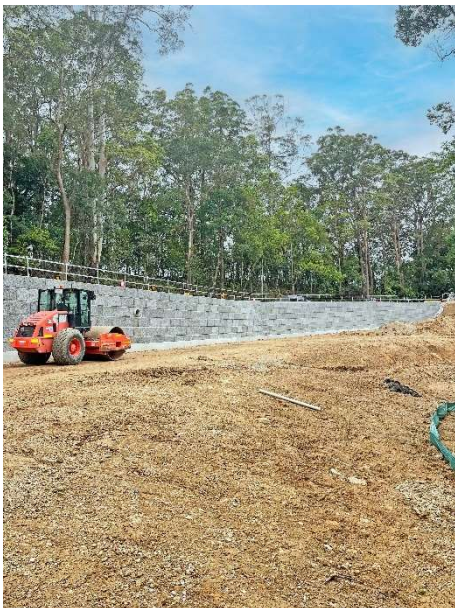
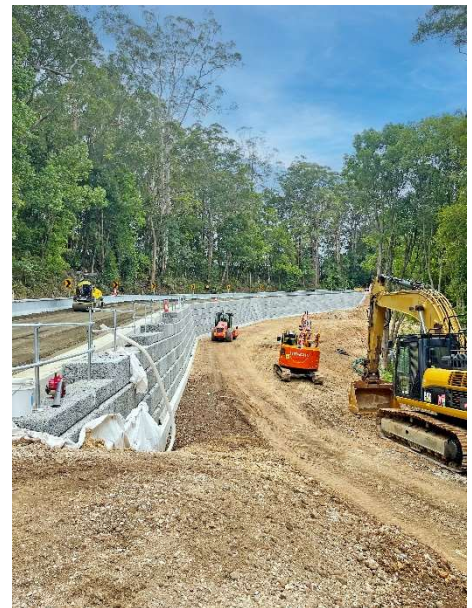
Site 1Km Works

The works are progressing on schedule for Nimbin Road with Site Km1.0 is on track to open before the end of the year. The total extension of the remediation works for the site is 120m with 239 piles now installed with the total length of 3,226 linear meters. Additionally, 150m³ of concrete have been used for the construction of the pile cap with 611 blocks placed on top of the pile cap to allow the reconstruction of the road.
